“Rebuilding the Walls of Jericho”

Preservation and Restoration of Dennis’ First Museum

The Jericho Historical Center
90 Old Main Street
West Dennis, Massachusetts 02670

2018 - 2022

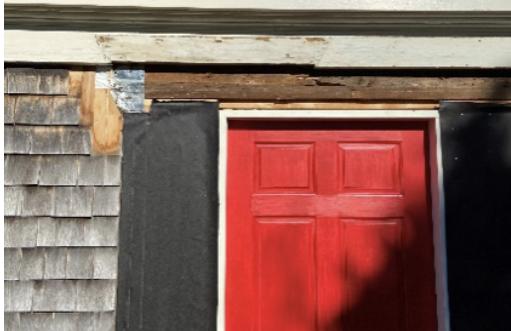
Hidden Window Header

During the carpentry, the header of that rear door was removed. It was then that a faint outline was seen of a smaller header offset to the left from the door opening. The width of that header was exactly the same as headers over the first-floor windows. Perhaps that rear doorway had actually once been a window in colonial times? If that were so then the challenge was to find where the original rear door had been. That started the search for any indication that another doorway had been in the Keeping Room which was the large room to the rear of the house.

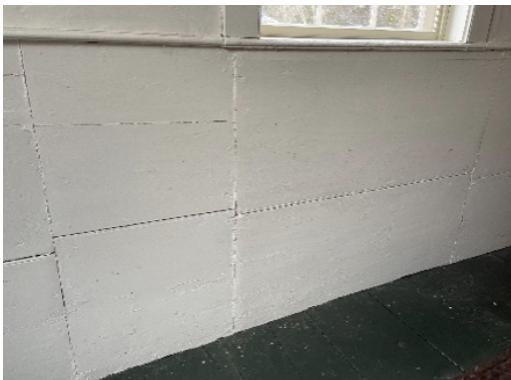
Former Rear Door Location

After careful examination of the woodwork in the Keeping Room, splits in the wainscotting boards at the end or south side of the room showed that a door had been there where a window is today.

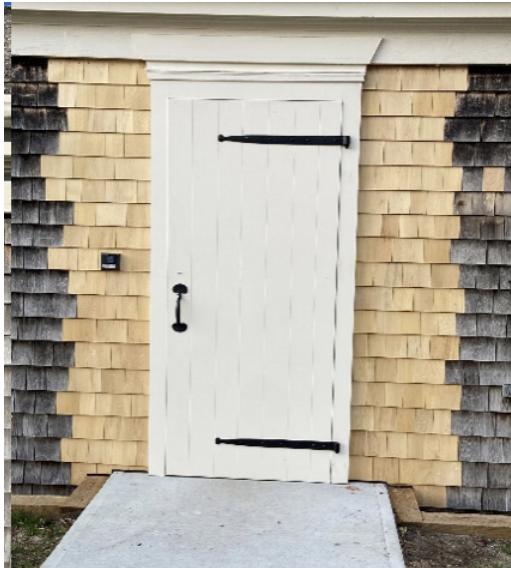
New Rear Batten Door

Poor also showed the original storm door. As opposed to the white aluminum and glass outer doors installed on the house in the 1970's, batten doors were visible. These are made up of boards about 8 inches wide, parallel in a row, and secured at the back by horizontal supports or battens. Both iron strap hinges and a thumb latch were often visible on the exterior doors of these early houses even though they were not in Poor's pictures of Jericho.

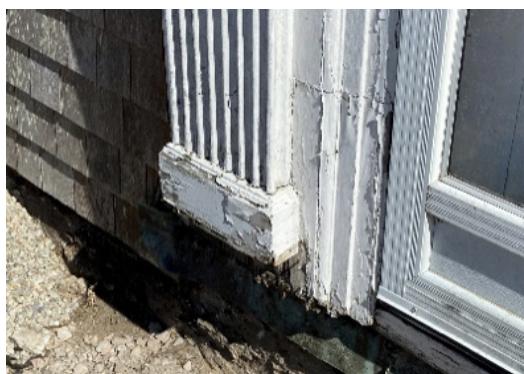
The Frontispiece (front door trim) was all intact but in poor condition due to extensive exposure to the elements. The plinth blocks had deteriorated and fallen away from the bottom of the fluted pilasters. Parts of the side moldings had also deteriorated as had the lintel moldings. Alfred Poor's book

Missing Plinth Blocks

showed that the plinth blocks were not original and that the fluted pilasters had actually extended to the bottom of the door casement. It was also evident that "dutchmen" had been used over the years to partially replace the deteriorated bottom casings on both sides. And in several cases even the dutchmen had deteriorated and been replaced a second time without much attention to the detail in Poor's book. During construction, all replacement trim around the front door was made from African mahogany to insure long term durability.

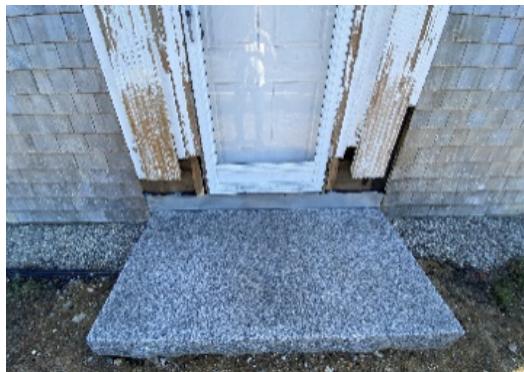
Decayed Pilasters

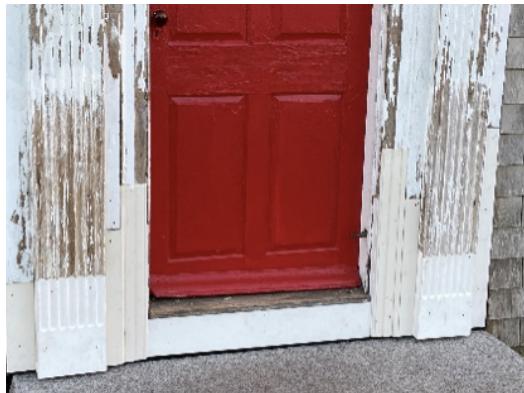
Mahogany 'Dutchmen' Replacements

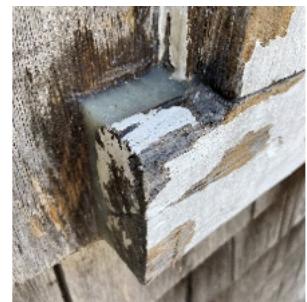
Epoxy Filler

Before any windows could be installed, however, the architectural trim of all 15 needed major work. Over the years the paint had peeled and exposed the wood. Pieces of trim having unique colonial era profiles were hand planed by the contractor. In other cases epoxy was used to fill the gaps.

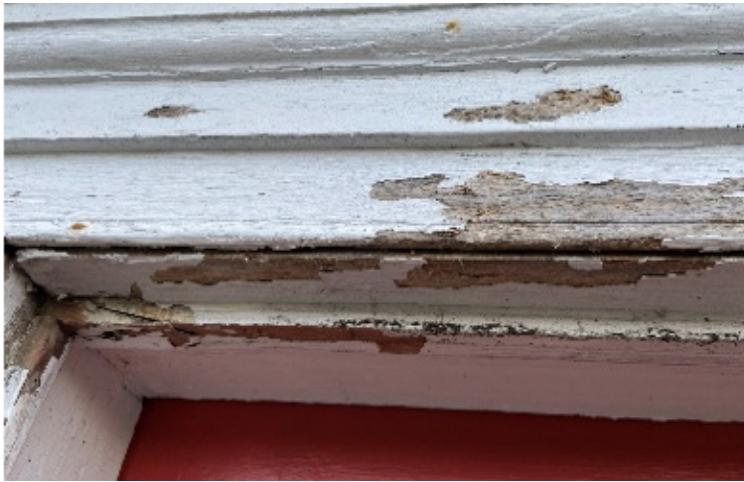
Deteriorated Trim

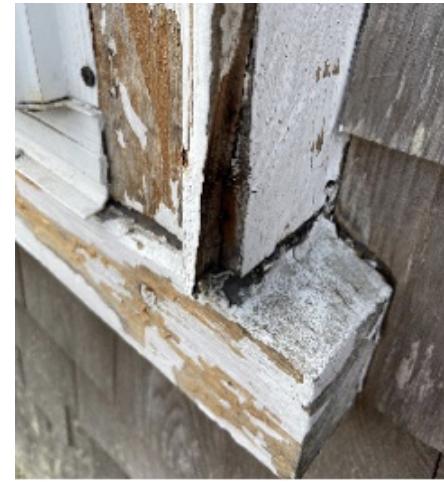
The second story windows presented a slightly different challenge. That is because the original frames had been removed when the 12 over 12 sashes were installed in the 60's or 70's. In its place were modern thin casements with small sills along the bottom. These needed to be replaced with frames that duplicated the originals in the first floor windows. These frames set out away from the walls by several inches. The general contractor was again able to work with the same craftsman who made the sashes, to reproduce the frames for the upstairs windows. And like the sashes, they were also made of African mahogany for long term durability.

Decayed Frame

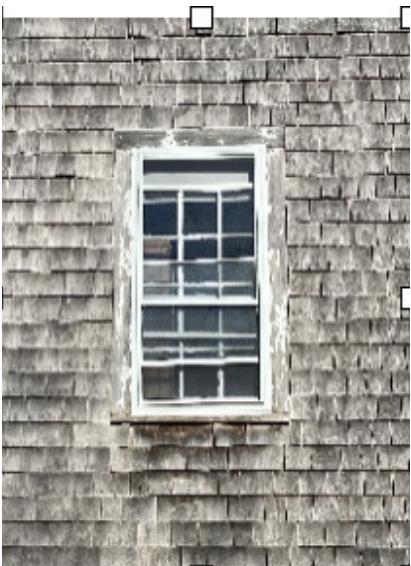
Another challenge was to find a style of storm window that did not detract visually from the new windows. The previous design was combination glass and white aluminum that had not held up well over the years. The added insulation/protection, though, from storm windows was considered a priority. But, any large sheet of glass that would be in the more traditional storm windows would mask the look of the reproduction glass from the outside. The solution was interior storms similar to those at the Josiah Dennis Manse. After an extensive search, a manufacturer was found in Connecticut who had an improved design to facilitate the removal and installation of the windows as needed. The Committee took a trip to Truro to examine these storm windows installed several years ago at the Truro Library. The design was impressive. The sealing mechanism was a “compression fit” as opposed to the more permanent screw installation. And since each window frame was different in size, the manufacturer made a site visit to insure the most accurate measurements.

Old Storm Windows

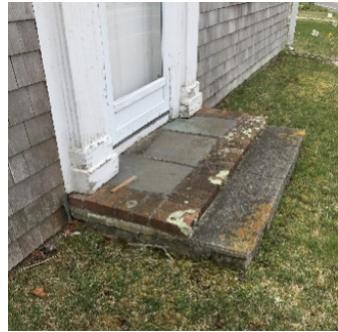
With such an impressive front door entrance to this ship captain's home, the challenge for the Committee was to decide the best front door step. The present one was a combination of flag stone, cement, and broken brick probably from the early 1900's. To get started, a survey was done of area houses of similar age to Jericho. Houses having higher thresholds had two steps, one smaller near the house and a large one further out. In most cases they were granite while some were brick and stone. With the Jericho threshold being fairly low to the ground, there was room for only one step. The choice was a 3' x 5' New Hampshire gray granite slab having a natural edge.

Original Front Step

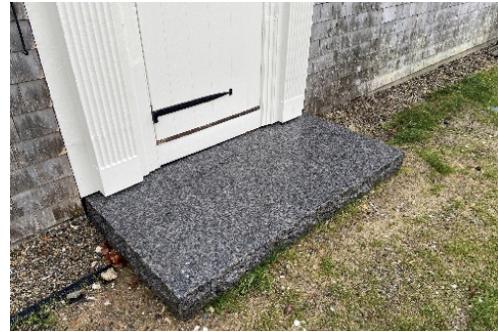
New Granite Step

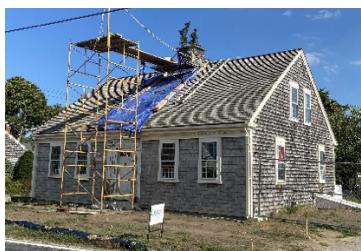
The Jericho chimney was painted white with a black rim along the top. Since there were several visible cracks in the chimney, a professional inspector was brought in to determine its structural integrity. No structural problems were evident but additional cracks were found in the exposed bricks. The accumulated layers of white paint over the years had acted as a water barrier. Water which had accumulated between the paint and the bricks and expanded during the colder months, thus damaging the bricks.

Chimney Replacement

To examine those cracks better, an environmental stripping agent was applied to remove the paint. That uncovered even more cracks. As a result, the decision was made to remove the chimney from the roof up and replace it with a similar design using reproduction bricks.

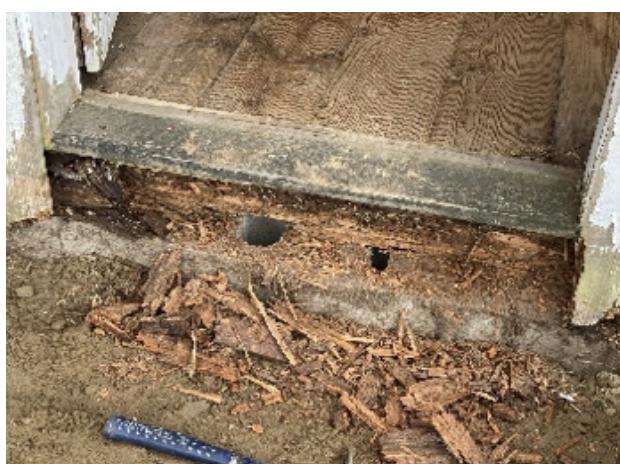
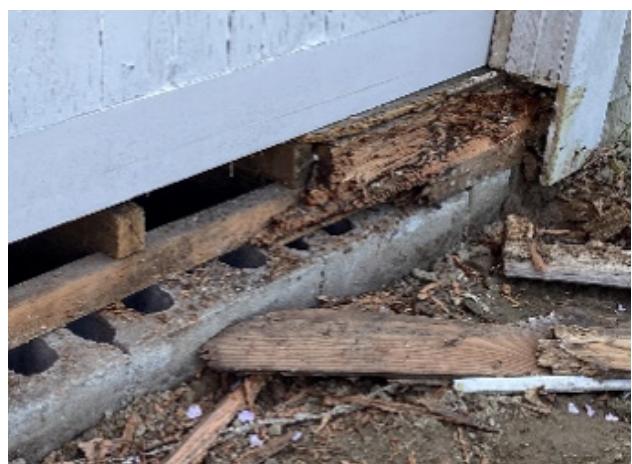
As the footings for the sidewalks were being prepared, however, the thresholds at the house and the barn were uncovered, revealing extensive deterioration right into the structural footings. That was a result of a combination of unexpected rodent infestation and water damage over many years. Two thresholds at the barn and one at the rear door of the house had to be removed to assess the full extent of the damage.

Barn Threshold

After extensive examination it was determined that the deterioration did not extend more than six inches beyond the door frames. New footing sections and thresholds were cut and pieced in place. At that point the work on the new sidewalks could continue.

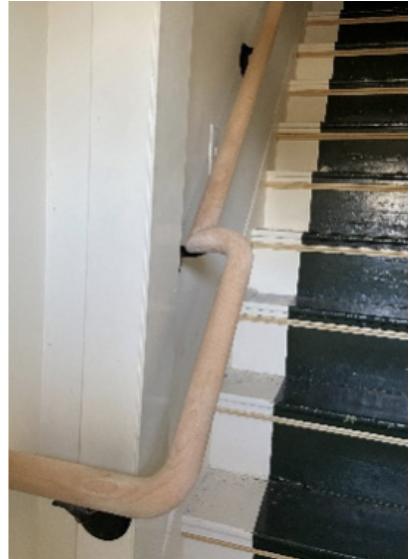
Interior ADA Changes to Stairs

Even though the MAAB did agree to many waivers, they did require a new front stair hand rail and additional trim to the stair treads to minimize tripping hazards. In the barn they required ramps between rooms when the floor height difference was more than 2 inches.

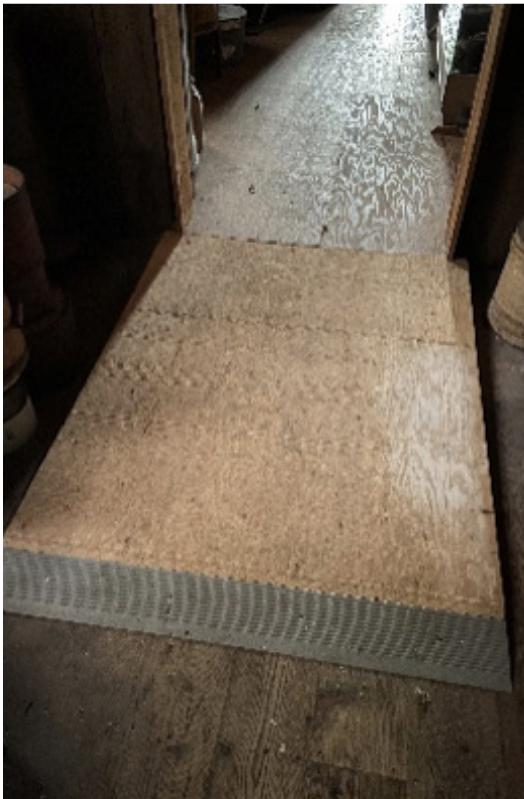
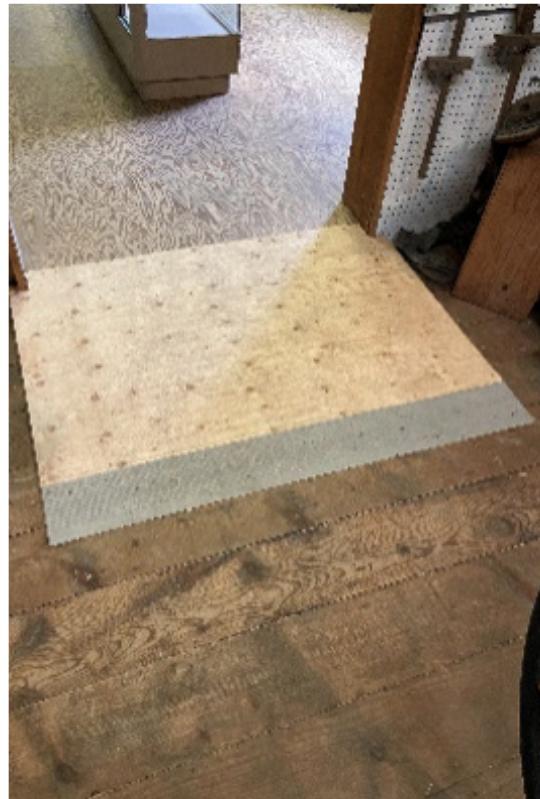
New Interior Barn Ramps
