“Rebuilding the Walls of Jericho”

Preservation and Restoration of Dennis’ First Museum

The Jericho Historical Center
90 Old Main Street
West Dennis, Massachusetts 02670

2018 - 2022

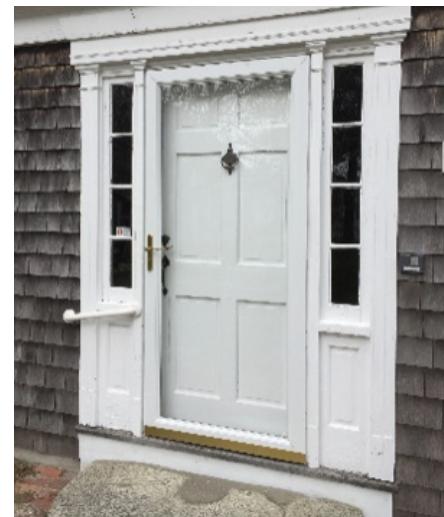
Back Door

When Jericho was privately owned in the late 1950’s and early 1960’s, the main entrance was the back door of the house. The reason was that the house was located very close to Old Main St. and the front door presented a safety problem for the owners and guests. As a result, the back door was enlarged by the owners and side window lights were added. The design was “Colonial Revival” and it enhanced the rear entrance.

In studying colonial architecture on Cape Cod from the early 1800’s, however, we saw that the rear door of a Cape house was normally small and plain in design. The reason was that it was used primarily by the family while guests rarely used that entrance.

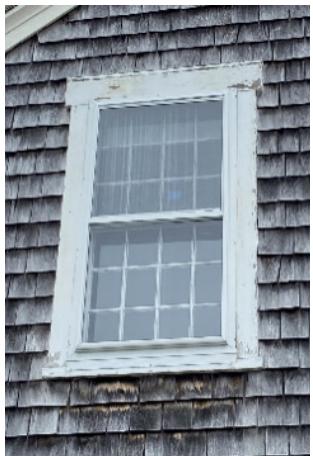
Former Windows

All 15 windows were of similar design with 12 over 12 sashes meaning that both the top and bottom sashes had 12 small panes of glass. Some of the other historic houses throughout Dennis had the same window design. Even newer houses from the 60's and 70's had that small pane design. Other historic houses, however, had a 6 over 6 design. Examination of the construction of the 12 over 12 Jericho windows concluded that they were fairly modern and perhaps from the 1970's. If the joinery had been mortice and tenon with pegs, then they could have been original.

Poor's book of 1932 showed that the Jericho windows were 6 over 6 and not 12 over 12. The Committee carefully examined the window design of other early houses. What they concluded was that for the most part during

The Committee concluded that the 6 over 6 design as shown in Poor's book was the best choice.

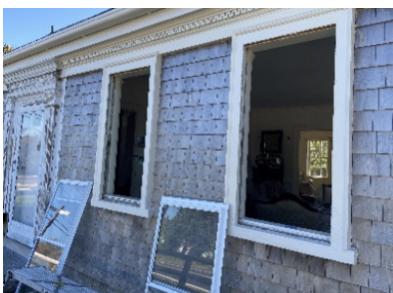
Original Frames

At first these new Marvin windows became the top choice for installation until the contractor removed the aluminum storm windows. The Committee began to examine the actual window casements in detail. The casements were the window frames and they were also a major part of the wall construction. All the original Jericho frames were mortice and tenon construction joined with pegs.

These frames had two roles: one being part of the wall construction and the second as the casement for the top and bottom sashes. The window sills were the bottom of the original frames and not separate pieces of wood.

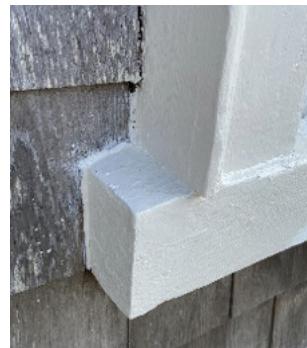
Restored Frame

Before any windows could be installed, however, the architectural trim of all 15 needed major work. Over the years the paint had peeled and exposed the wood. Pieces of trim having unique colonial era profiles were hand planed by the contractor. In other cases epoxy was used to fill the gaps.

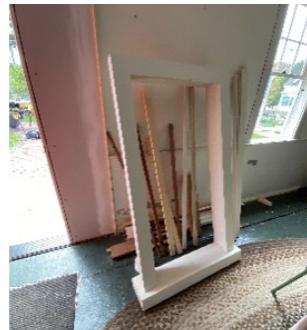
New Frame

The second story windows presented a slightly different challenge. That is because the original frames had been removed when the 12 over 12 sashes were installed in the 60's or 70's. In its place were modern thin casements with small sills along the bottom. These needed to be replaced with frames that duplicated the originals in the first floor windows. These frames set out away from the walls by several inches. The general contractor was again able to work with the same craftsman who made the sashes, to reproduce the frames for the upstairs windows. And like the sashes, they were also made of African mahogany for long term durability.

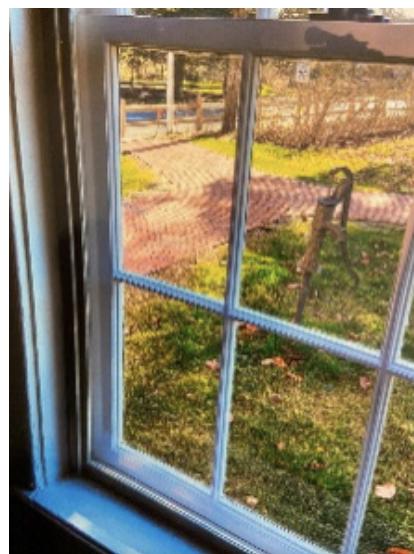
Installed Storm Windows

Another challenge was to find a style of storm window that did not detract visually from the new windows. The previous design was combination glass and white aluminum that had not held up well over the years. The added insulation/protection, though, from storm windows was considered a priority. But, any large sheet of glass that would be in the more traditional storm windows would mask the look of the reproduction glass from the outside. The solution was interior storms similar to those at the Josiah Dennis Manse. After an extensive search, a manufacturer was found in Connecticut who had an improved design to facilitate the removal and installation of the windows as needed. The Committee took a trip to Truro to examine these storm windows installed several years ago at the Truro Library. The design was impressive. The sealing mechanism was a “compression fit” as opposed to the more permanent screw installation. And since each window frame was different in size, the manufacturer made a site visit to insure the most accurate measurements.

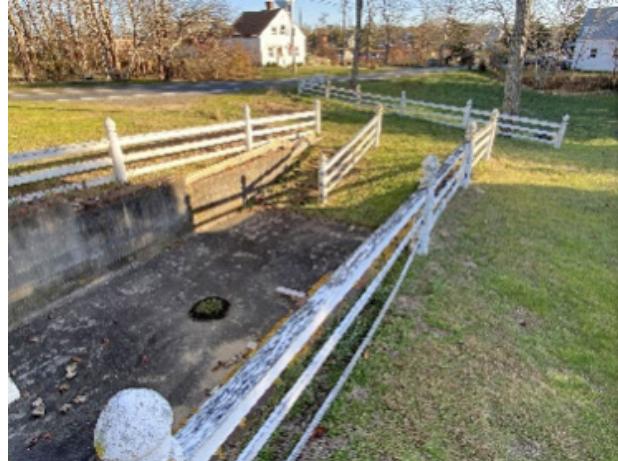
Former Fencing

For many years, the Jericho property has had a white, painted wood rail and cement post fence around its perimeter and entrance areas. That fence was probably added in the 1980's and was widely used throughout the Town. Over the recent years the fence along Old Main Street had fallen into disrepair

and had not been replaced. The lack of a fence there presented a problem as there would be little protection for guests and visitors walking in front of the house.

Pictures from Poor's book shows a two rail, split rail fence along the property in the 1930's. A post-card from 1970 showed a similar design. That fence would weather naturally and blend in with the color of the building shingles. It also would be easier and less costly to maintain and could readily be replaced if a single rail or post were needed. The Committee felt that a two-rail, split-rail design was closer to what was originally there in the 1800's.
